SMARTRACING™

Rear Factory Bump Stop Modification

Instructions Rear Factory Bump Stop Modification

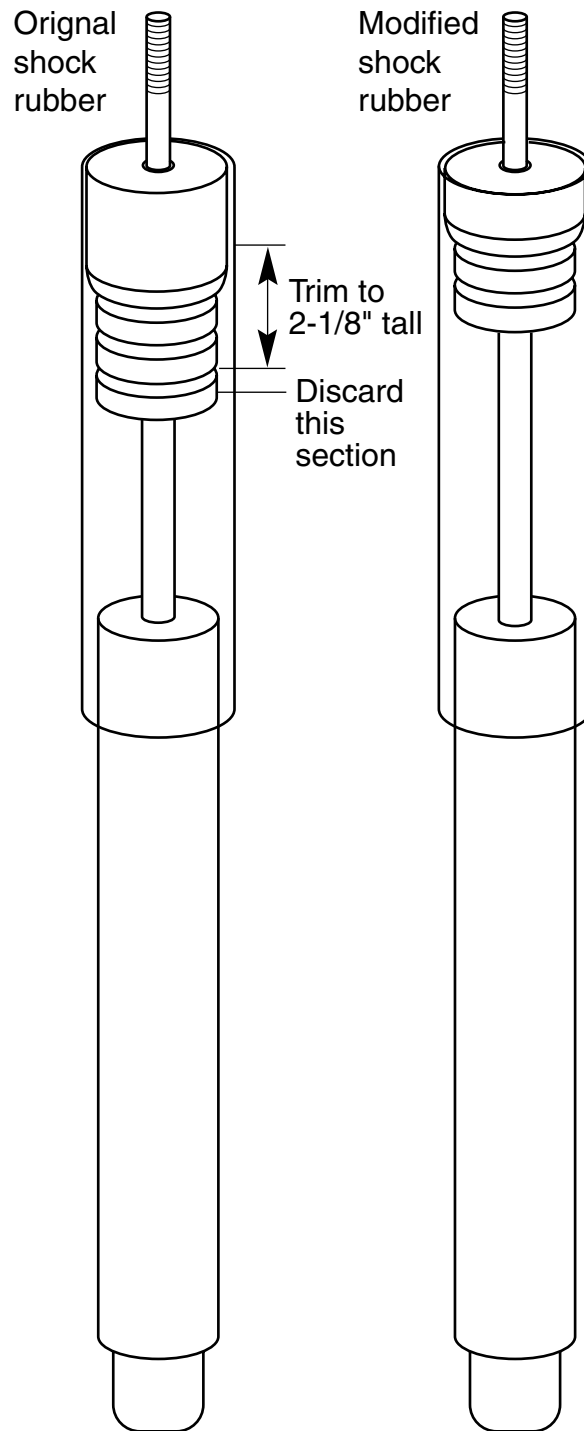
The following illustration provides you with a visual of how the rear factory bump stops (rubbers) are installed on the rear shocks of '89 and earlier 911's and 930's. This is very important to know because if you lower the car beyond a certain point, the shocks will bottom out on the bump stops prematurely and send the spring rates through the roof, resulting in very unpleasant - even diabolical handling characteristics. Something as simple as this in the rear of a car can cause it to suddenly oversteer or even snap-spin.

The illustration shows the bump rubber before and after.
